PROOF OF PERFORMANCE

Offline Filter used to remove moisture ingress

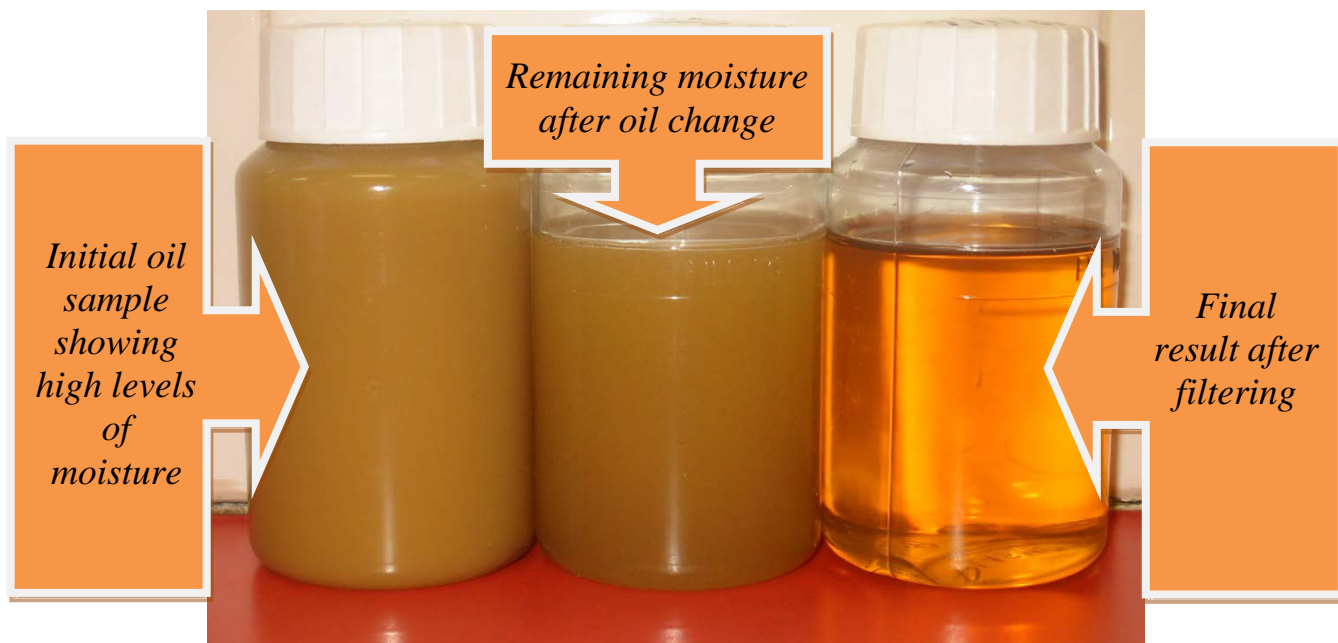
Regular oil analysis detected high levels of moisture ingress resulting from a defective heat exchanger, a regular occurrence on any injection moulding machine. An immediate oil change was performed to remove water and increasing ferrous wear debris levels. Caroma Dorf, Australia's foremost designer, manufacturer, importer and distributor of sanitary ware and bathroom products, contacted Precise Lubrication for a suitable solution to allow production to continue on this critical injection moulding machine.

With the initial change of oil unable to remove all of the moisture that remained within the hydraulic system, Precise Lubrication offered an offline filter to remove remaining levels of moisture.

- Remaining moisture eliminated.
- Cleanliness levels improved.
- Ferrous wear debris removed.
- Minimised unscheduled downtime.
- Due to high moisture holding capacity of filter elements, only one set of elements was required.
